# Technical Bulletin

Bulletin Number: TB 500 Revision Number: R-03

**SUBJECT:** COIN CHUTE ALIGNMENT WITH TOP OF COIN MECHANISM

**MODELS AFFECTED:** All VRV Models with Vender Defender Coin Chute.

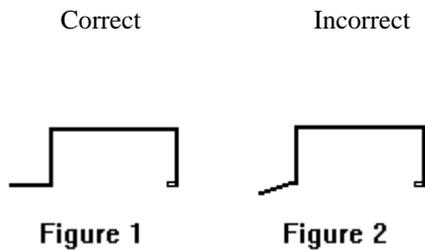
Figure 3

Note: There should be a 90° break in the flange as shown in figure 1. Figure 2 shows a flange that is not made properly and the flange is not at 90°. This will cause alignment problems with the coin chute and changer.

1. Check the depth of the access door at the top and bottom. See figure 3. The measurements of "A" and "B" should be the same. If these are off it will cause alignment problems with the coin chute and changer.

To correct the problem, the customer can replace access doors with serial numbers as a warranty exchange. If items 1 and 2 check out O.K., then the customer can try longer changer mounting screws with nylon bushings listed above.
