Technical Bulletin

Bulletin Number: 521 **Revision Number:** 0.0
Release Date: 04/07/2014 **Revision Date:** 04/07/2014

Subject: Scratch removal on media pills due to credit card swipes

Models Affected: Merchant/Bevmax Media: 471, 472, 186, 187, 3800-6, 5800-6

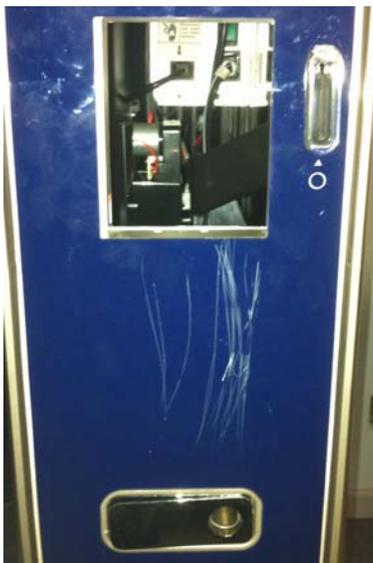
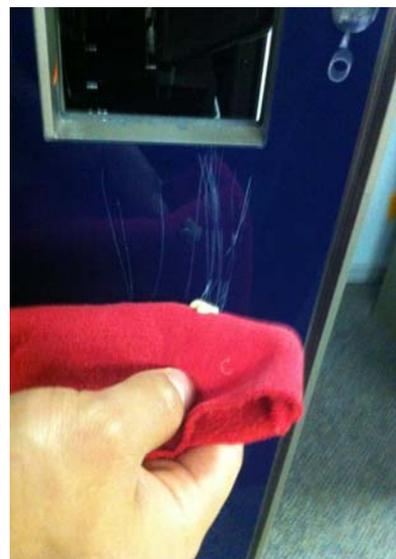
Reason: To counter the scratch marks left by plastic cards striking the surface of the pill during a transaction. This is an alternate solution to replacing the pill.

1. Locate area where scratch marks are present. Pour 1-2 drops of scratch cleaner on a dry, lint free rag and softly clean the area of scratches (if you need more of the solution add another 1-2 drops).
